# **INDOOR AIR QUALITY ASSESSMENT**

**Henry E. Warren Elementary School  
73 Fruit Street  
Ashland, Massachusetts**

Prepared by:  
Massachusetts Department of Public Health  
Center for Environmental Health  
Emergency Response/Indoor Air Quality Program  
July 2006

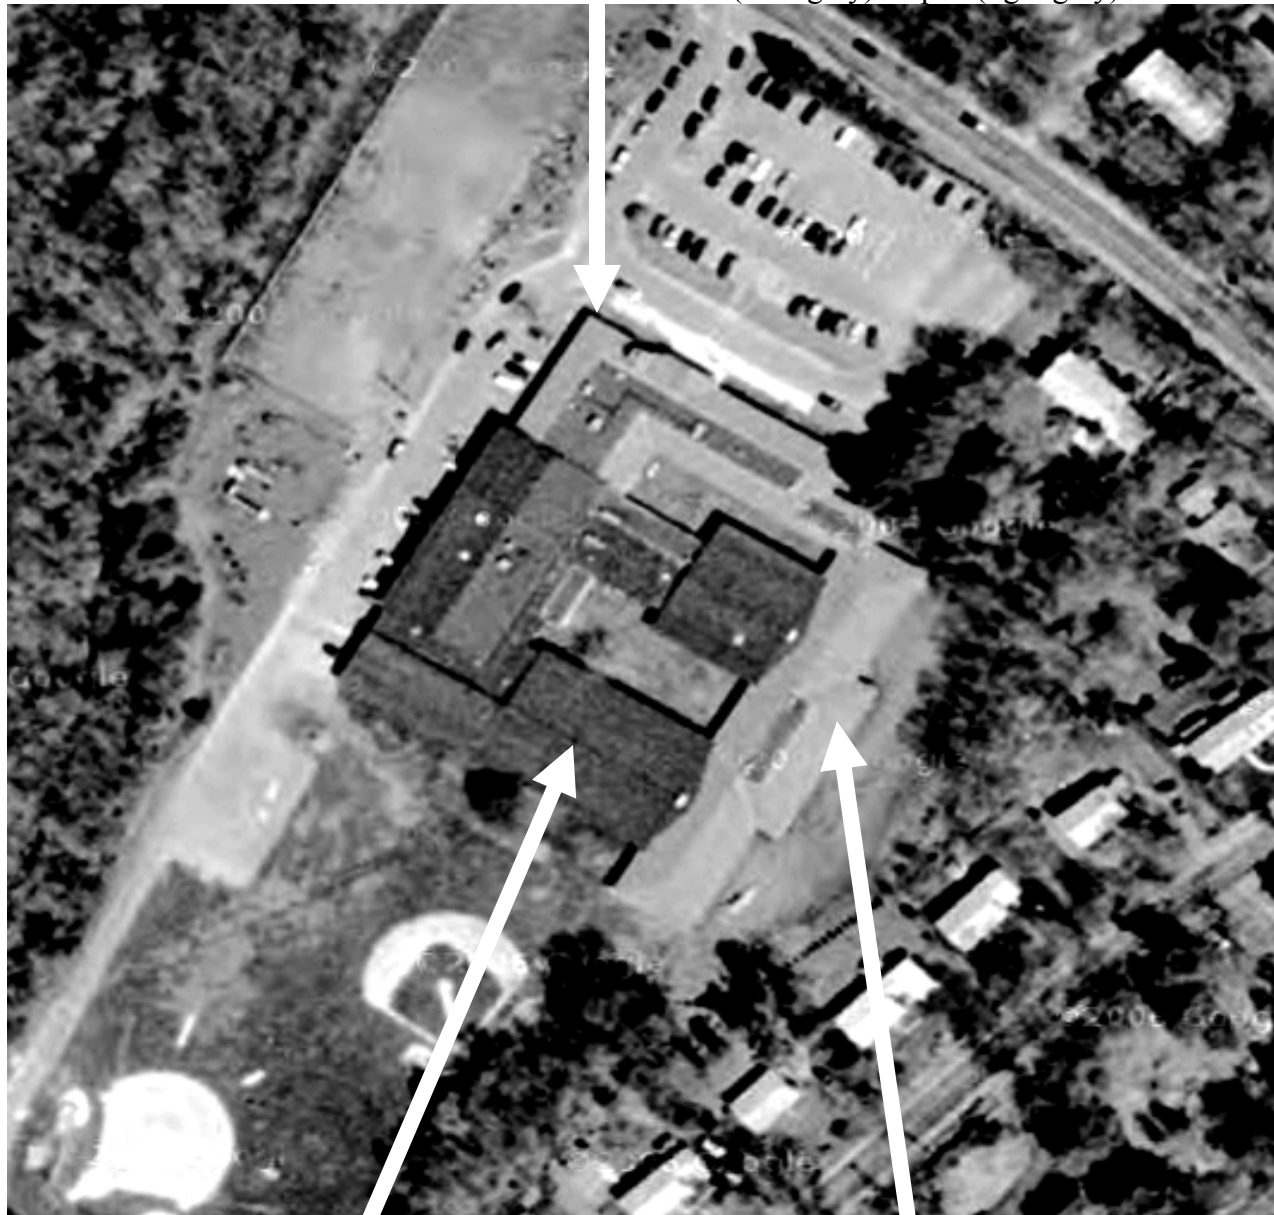
**Map 1**  
**Henry E. Warren Elementary School Aerial View**

Front Offices with combination flat (dark gray)/sloped (light gray) roof

Origin? Wing

1992 Addition

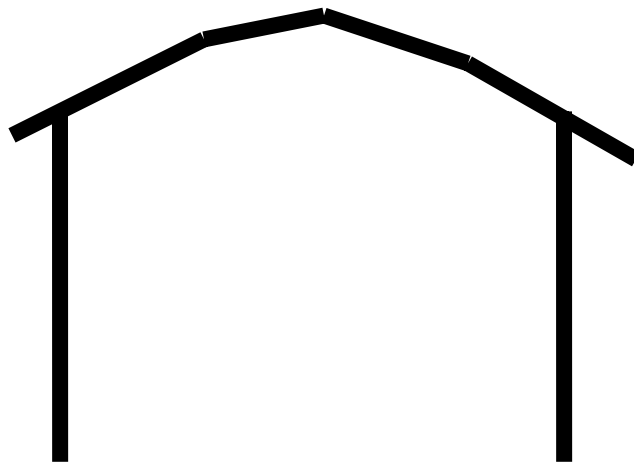
**Figure 2**  
**Mansard roof, general shape**

The 1992 wing has a truncated mansard roof (Figures 2 and 3), with a flat roof fitted over the center of the building instead of one with a slight peak. Installed on the flat section of the roof are air handling units that provide mechanical ventilation for offices (Picture 1). Water damage was observed beneath the junction of the flat/sloped areas of the truncated mansard roof or at the junction between the original and 1992 wing. This would indicate that the transition between the flat and sloped areas of the roof have either missing or incomplete flashing. In general, where two dissimilar materials meet on the exterior of a building, the
